# REPAIR OF THE INVERTED GEAR RACK IN-WALL (SCHWINTEK) SLIDE-OUT SYSTEM

TSB Number:	146-001-2022		
Product:	Inverted Gear Rack In-Wall Slide-Out System manufactured between October 2021 and January 2022		
Date:	June 24, 2022	Labor Rate:	5.0 Hours Allowed (2.5 hours per side)

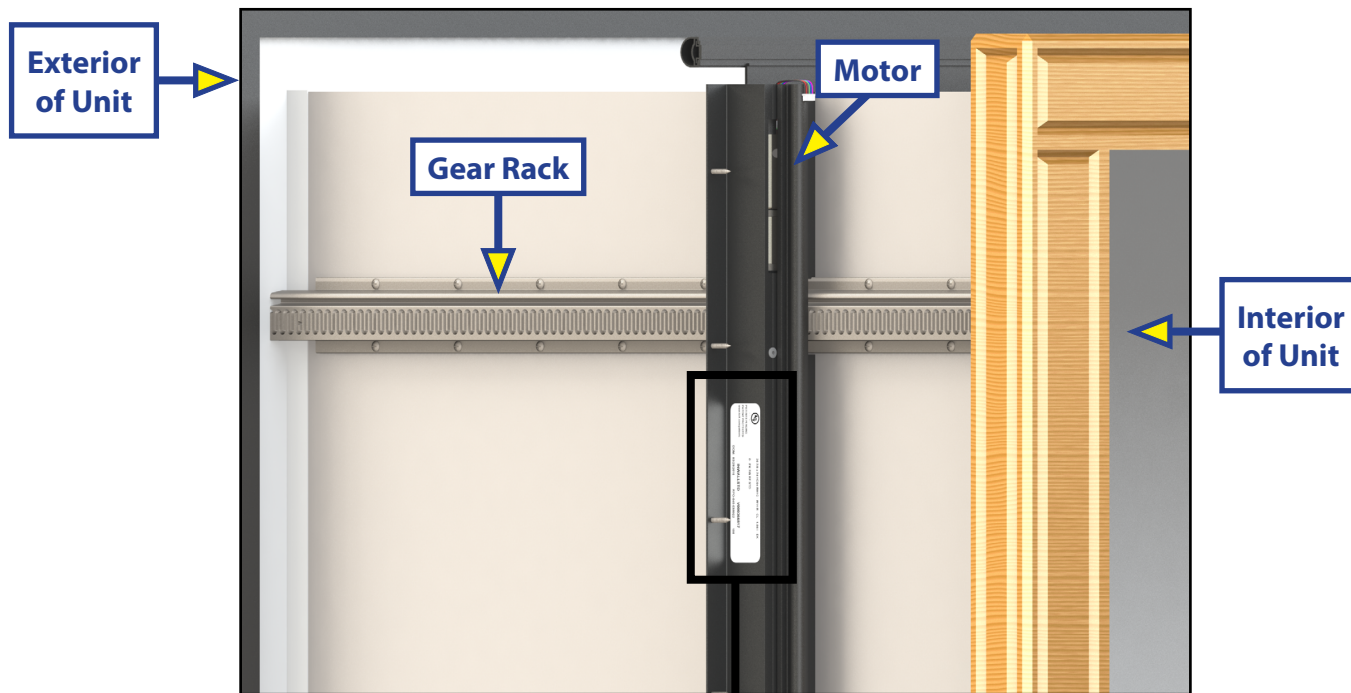
The specific inverted gear rack systems will have manufactured dates around Oct. 1, 2021, through Jan. 6, 2022. Dates are shown on the variant code tag located on the H-column. See location below.
