# TIRE INFORMATION SERVICE BULLETIN

## SIDEWALL INDENTATIONS IN RADIAL TIRES

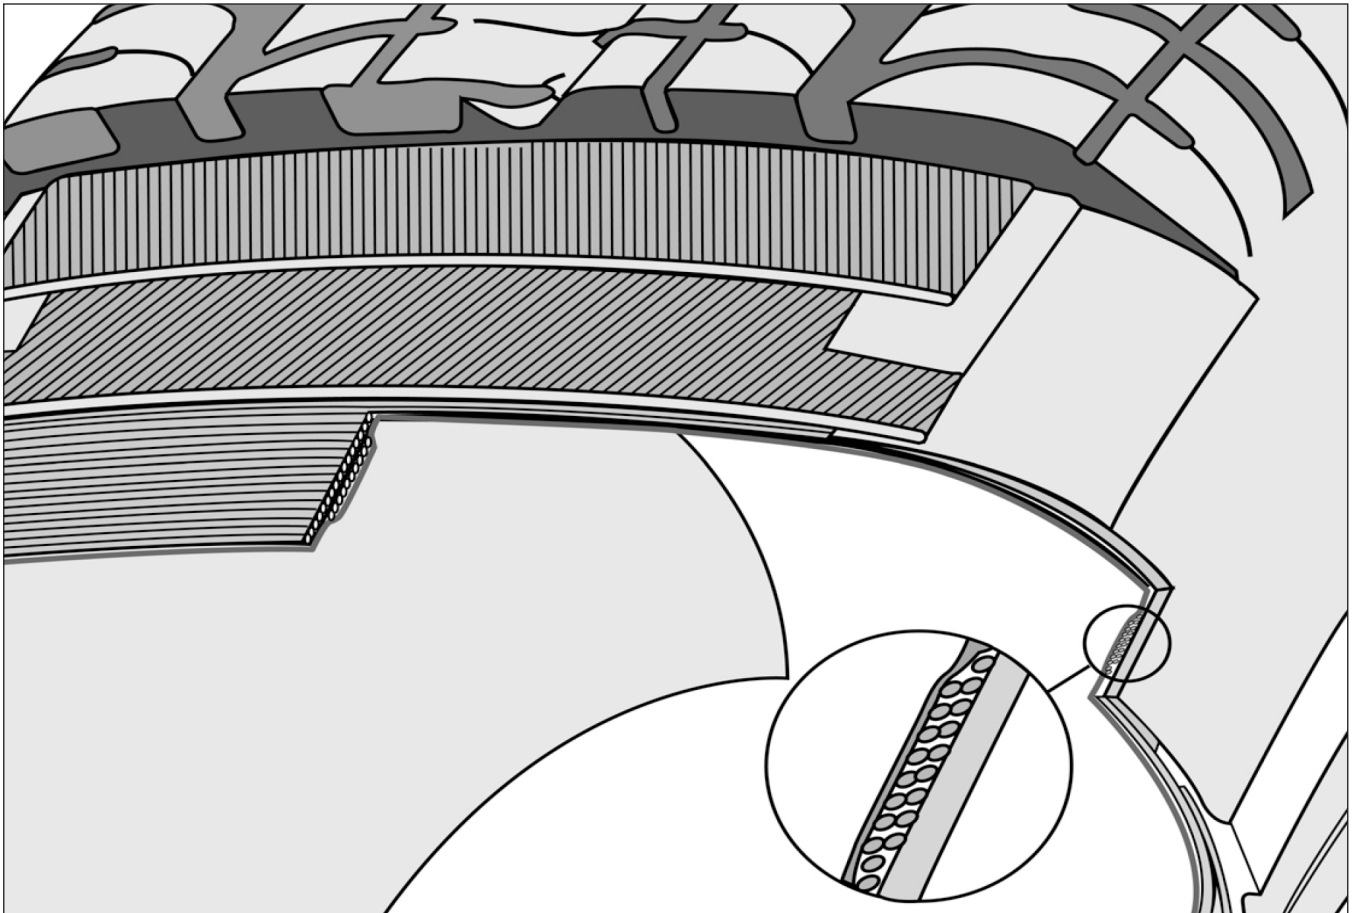
Sidewall indentations are a cosmetic characteristic and will not affect the performance of the tire. If bulges, rather than indentations, appear on the sidewall or if there is any question concerning the sidewall appearance, the tire should be examined by a tire service professional.
