Raven RV Repair LLC  
Ryan Zeigler  
Owner/RVTAA Certified Technician  
3/27/2025  
Furnace Blockage

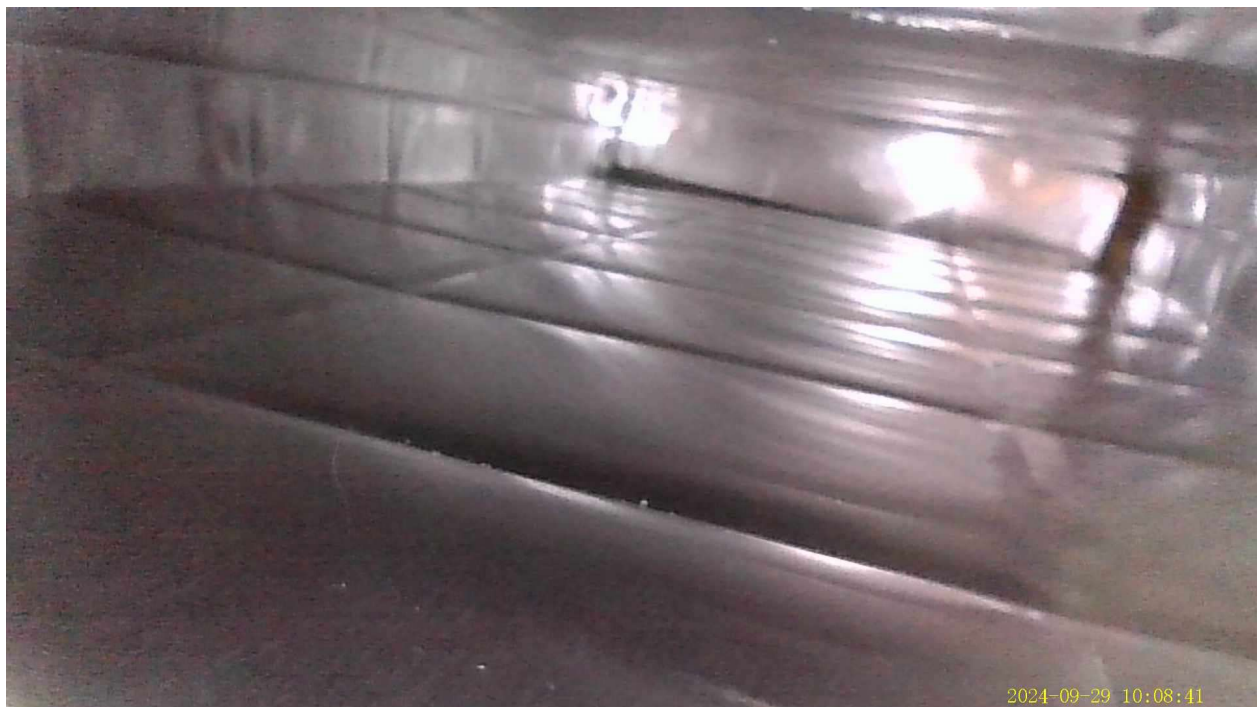
Client stated that furnace was not working. Upon assessment, furnace passed trial for ignition and successfully produced heat, but airflow was noted to be greatly diminished in ductwork. An endoscope was used to enter the closest duct to the furnace, and the finding is pictured below:

It is my suspicion that this duct was improperly installed by the manufacturer and would require removal and replacement of the furnace dump section to allow airflow into the ductwork.

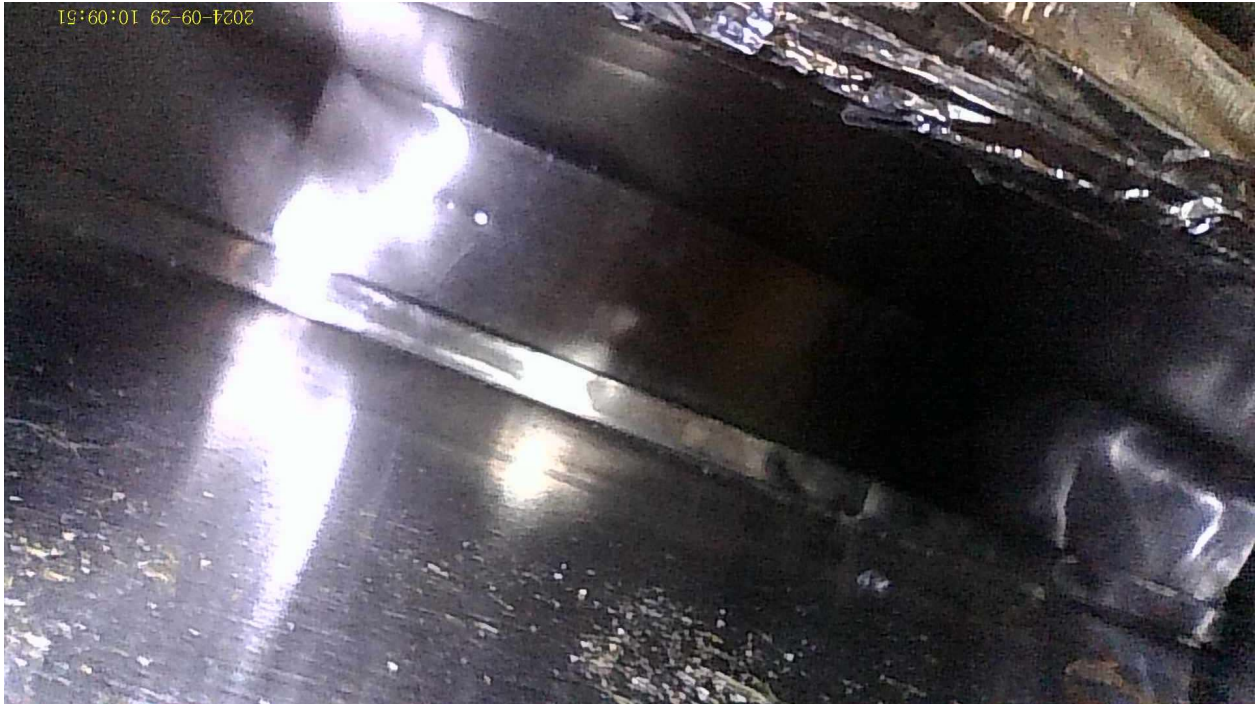
At first appearance it was thought that possibly the cut out for the furnace dump was dropped into the duct and caused this blockage. Furnace was then removed to see if it could be accessed from the dump. Below is a picture of the same blockage from the furnace dump:

When attempting to reach in by hand and adjust this blockage, it was noted by palpation that the top edge of this blockage is actually a 90 degree bend of the same metal plate, and it cannot be adjusted or removed. It was also noted that this section of ductwork, directly beneath the furnace dump, extended all the way to the exterior wall. With further assessment from endoscope, the left side (bathroom side) of this section of ducting appeared to have an unfinished cut that seemed to be enclosed by a slightly larger diameter duct almost like it was used as a cap. Sadly, a quality photograph of this was unable to be obtained with the scope.
