# TIRE INFORMATION SERVICE BULLETIN

## SIDEWALL INDENTATIONS IN RADIAL TIRES

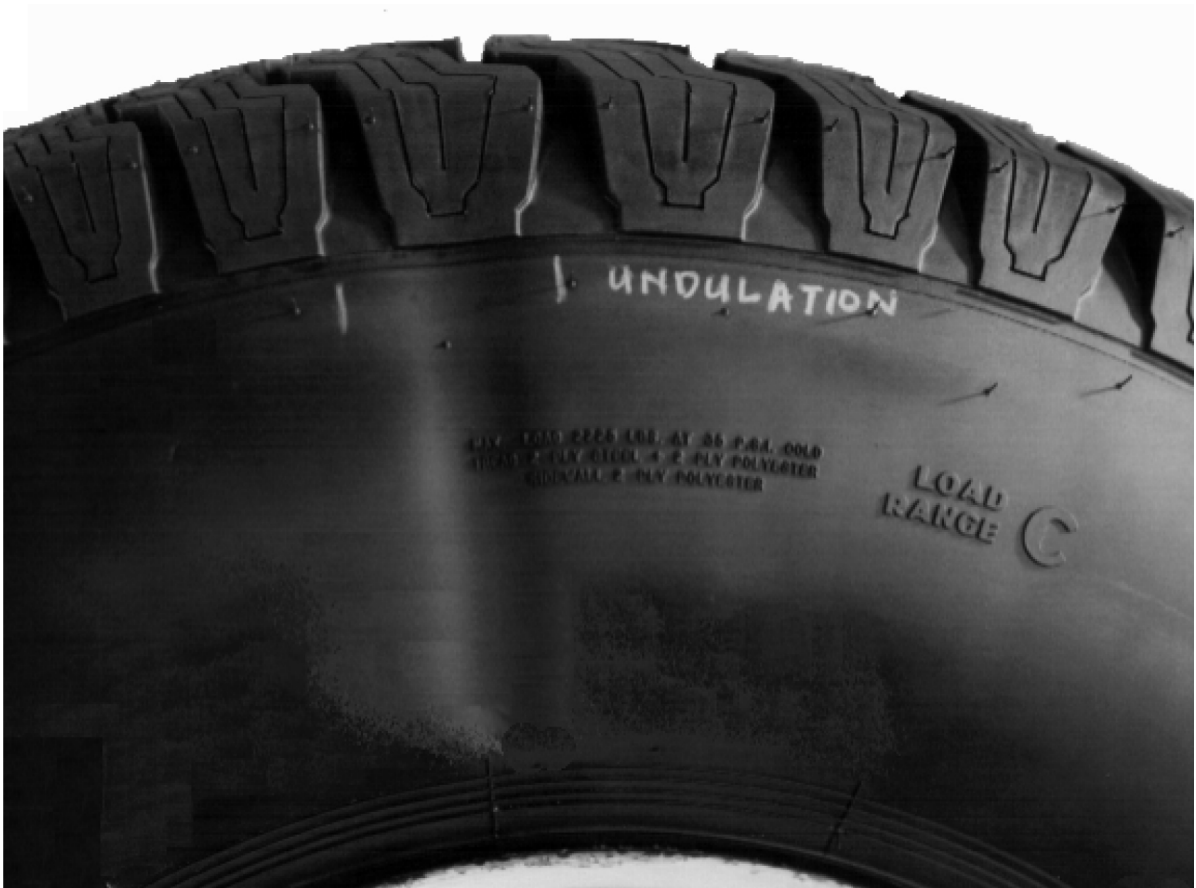
The condition, sometimes referred to as sidewall undulations, is a common characteristic of radial tire construction. These indentations are more noticeable in tire sizes with higher aspect ratios and/or higher inflation pressures.

In a radial tire the body ply cords run straight across the tire from bead to bead. The joining of the ply material creates a narrow overlap of ply cords in the radial direction at each junction. These overlapped ply cords slightly restrict the natural expansion of the sidewall when inflated. This results in an indentation. Since the belt plies reinforce the tread, only the sidewalls are indented.

Sidewall indentations are a cosmetic characteristic and will not affect the performance of the tire. If bulges, rather than indentations, appear on the sidewall or if there is any question concerning the sidewall appearance, the tire should be examined by a tire service professional.
