**Preauth**

We have a toilet valve that needs replaced and we are seeking preauthorization.

Complaint: Toilet purchased 10/20/2025 and is leaking  
Cause: Tech found the water valve is leaking water  
Correction: Replace valve and test

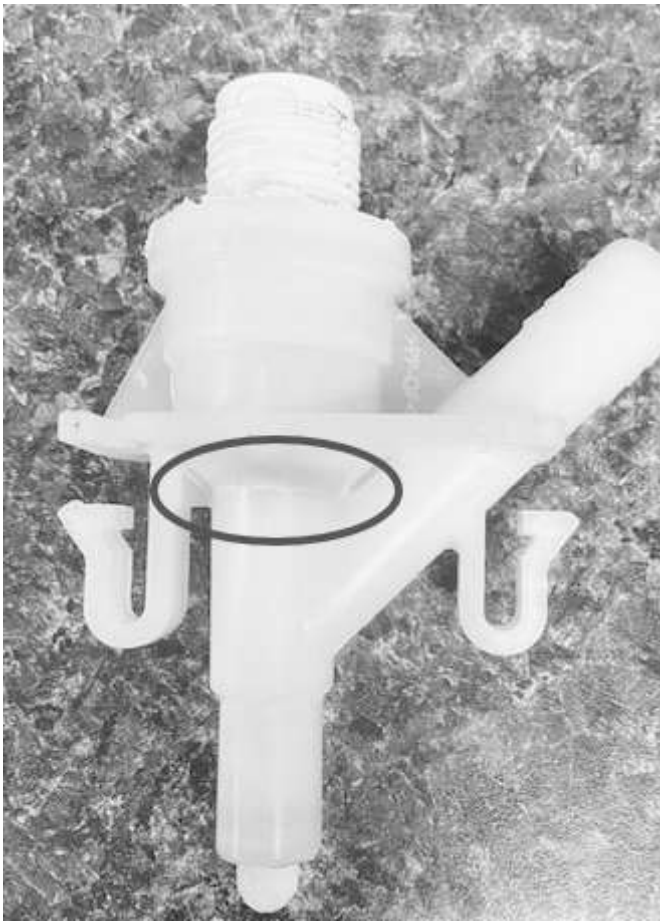
There is a visible stress mark seen to this valve, which is not covered under warranty.

This indicates improper water pressure, or improper winterization/freeze damage.

Dometic respectfully denies this claim.
