IMPORTANT SAFETY RECALL

NHTSA RECALL: 24V040
FR ID: 225-1723

RECALL 24V040 / 2024-035 REMEDY INSTRUCTIONS

LEFT HAND MOTOR WEDGE INSTALLATION

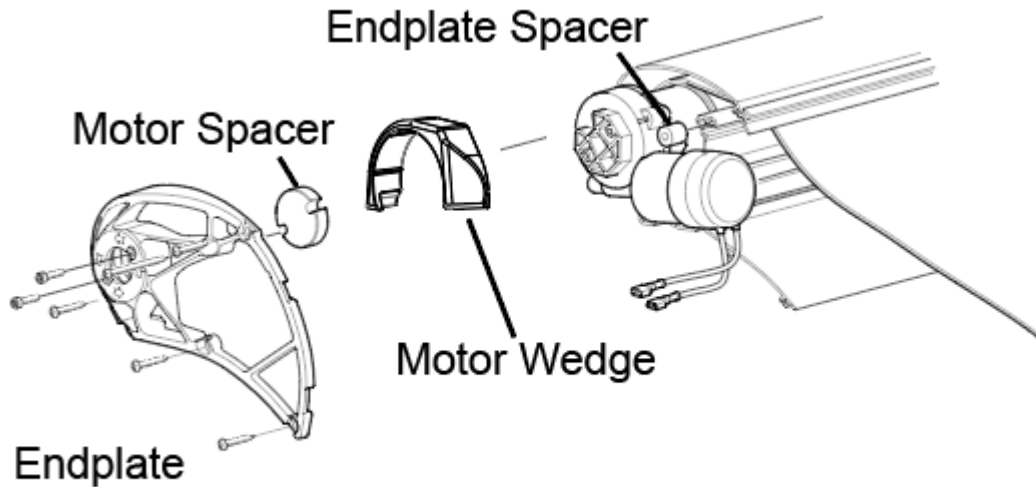
ragm015g

This manual covers the installation of a motor wedge into the existing Carefree Freestyle Evolution awning. The motor wedge is used to provide additional support to the motor in normal operations. Below is a schematic showing the motor wedge, a Left Hand motor is shown.

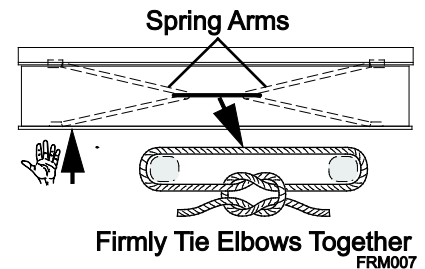
1. Disconnect power to the awning.
2. If the awning is extended: Carefully push the lead rail toward the case so that the arms collapse. While holding the lead rail in this position, firmly tie the elbows of the spring arms together. Use a minimum 1/2" rope - do not use bungee cords. When tying the rope, use a non-slip knot such as a square knot or equivalent.
3. If the awning is closed: Secure the lead rail in the closed position with at least 3 zip ties (tensile strength of 40lb or above) spaced equally along the awning.

CAUTION Failure to secure the lead rail as described will allow the spring arms to unexpectedly extend out possibly causing personal injury and damage to the awning.

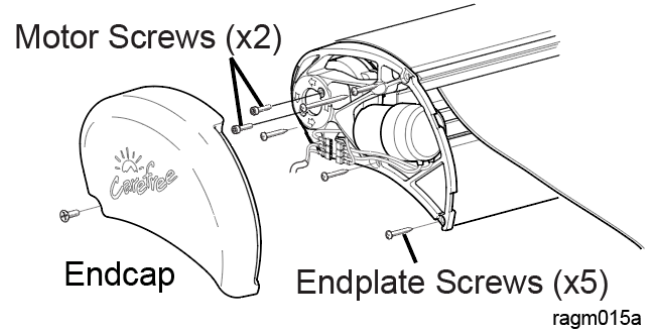
- Remove the motor end cap screw and remove the Endcap and set aside. For installed awnings, you may need to loosen the bracket bolts to gain access to the motor Endcap, depending on motorcoach model. Please reference service manual 070036-301 for additional information if you need to partially remove your awning to perform the motor wedge installation procedure.

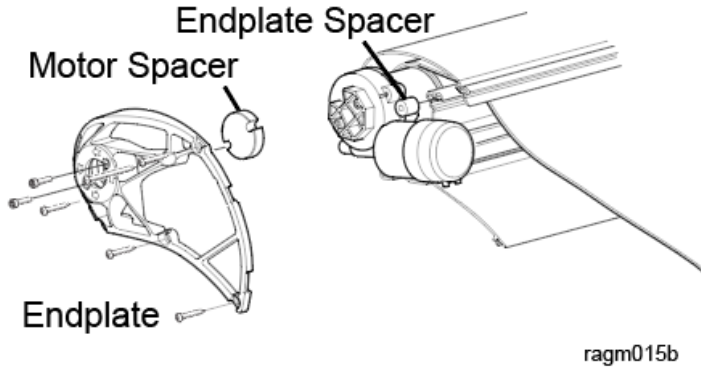
- Remove the motor screws (x2) and the endplate screws (x4) using either a T20 Torx head bit and the longer rail screw (x1) using a #2 Phillips head bit. Some awnings were installed with all 5 screws being the Phillips head screw.

- Pull the endplate away from the case. Take care to not lose the small Endplate Spacer. The Motor Spacer should stay wedged inside the Endplate.

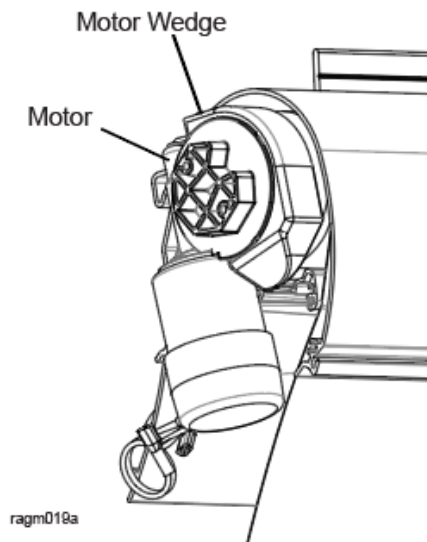
- With a flashlight, inspect the motor housing. Do not remove the motor from the roller tube. Pay particular attention to this highlighted zone. Inspect for any cracks anywhere on the motor housing. If there are no cracks visible, then the motor can continue to be used.

- If there are cracks, please follow the instructions detailed in the section **REPLACING THE MOTOR** in service manual 070036-301
- Install the motor wedge over the gear motor. The wedge will only fit one way onto the motor.

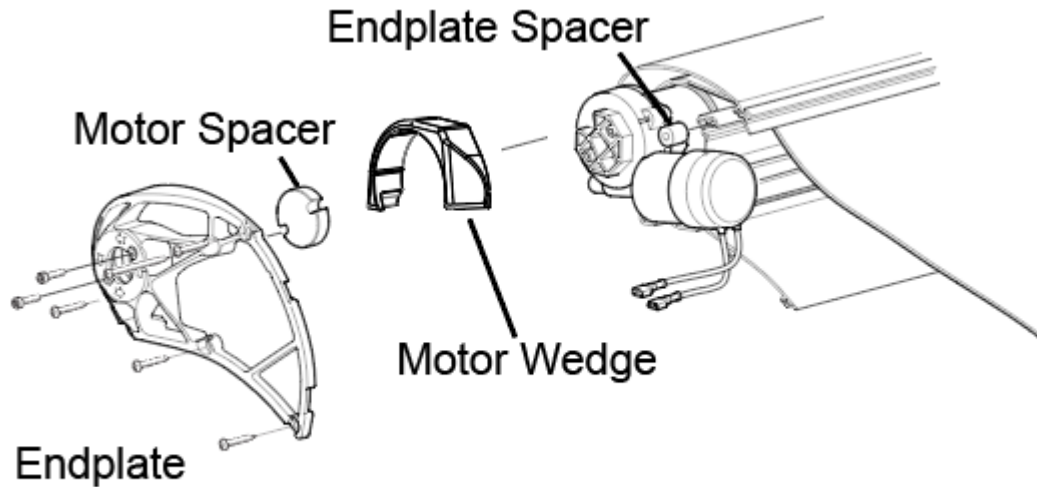
ragm015g

- After installation of the motor wedge, reassemble all the parts. Pay particular attention to the Endplate Spacer, which will be loose once you remove the Endplate.

11. Attach the end plate to the motor with the motor screws provided in the replacement kit (x2). Use a #2 Phillips head bit and a torque limiting driver. Drive the screws until they are tight.

12. Align the screw holes in the end plate and attach the new 1 inch Torx head screws to the awning case (x4). Use a T20 bit to drive the Torx head screws. Use a #2 Phillips head bit to drive in the longer screw in the endplate spacer. In some cases, the 1 inch Torx screw may not bite into the aluminum, especially at the location that uses the Endplate spacer. It is acceptable to reuse one of the longer Phillips head screws in that location if necessary.

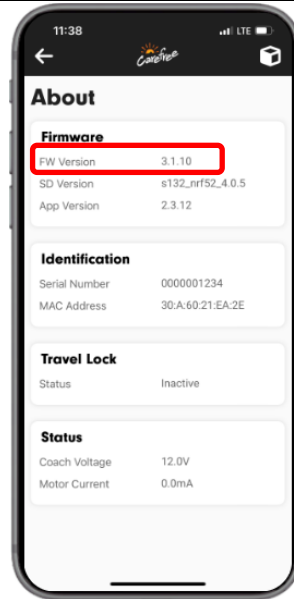
Reopen the app, reconnect to the awning, click on the cogwheel, and scroll to the About screen. Verify FW version 3.1.10 is loaded. Then proceed to test the app.

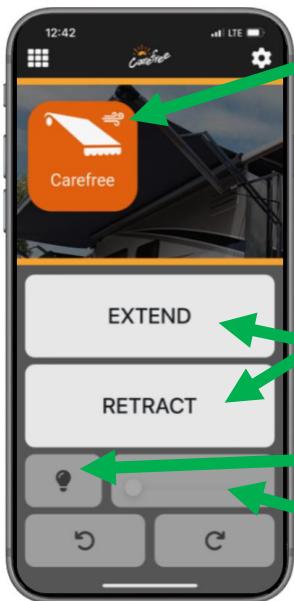
Verify the wind sensor is working – This wind symbol should be present, and White. If it is Black or missing, you must reconnect the wind sensor. Please refer to 070029-201 Carefree Connects Mobile app for pairing instructions.

Extend and Retract the connected awning – These buttons should fully extend and fully retract the awning

If the BT12 control module has the LED chip, this symbol will appear – Cycle the LED lights on/off, and verify that dimming controls are working.
