Customer Service Campaign

Visual Inspection for Momentum and Solitude Upper Deck Wall Securement

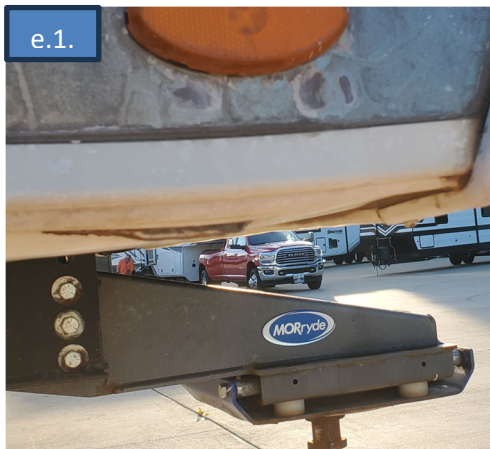
1. Screw cover separation around the front bulkhead - see *Photo Example e.1.*
2. Deformation or cracks at the expansion joint located under the upper deck slide outs - see *Photo Example e.2.*

If any of these conditions are present, please contact Grand Design Customer Service via the information provided in your cover letter for next steps.
