Steven Black's RM2451 refrigerator

I had spoken with Cole who provided your email address to reach out regarding Mr. Steven Black's refrigerator model # RM2451 w/sn# MB74501204.

Nature of Complaint: Fridge not cooling
 Part Required for Repair: Replace fridge

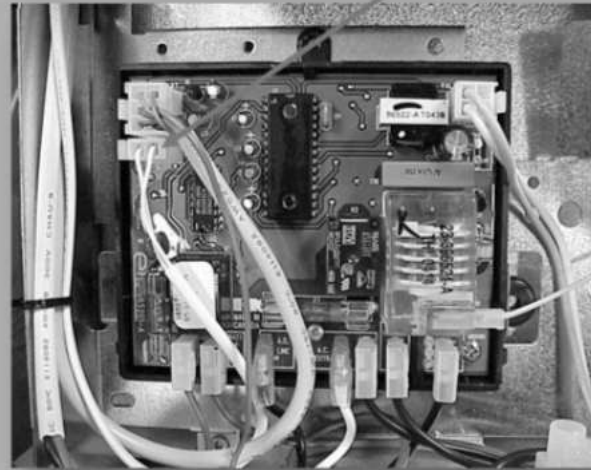
Unplug at P2

Disconnect the thermistor from the control board at **P2** (with the thermistor unplugged no temperature is sensed, therefore, it will run continuously). This was designed intentionally so that if the thermistor fails the unit will get as cold as it possibly can since there are no error codes to display and warn the customer that the thermistor has failed.

To Perform a Bypass Test of the Cooling Unit
