**Steven Black's RM2451 refrigerator**

I had spoken with Cole who provided your email address to reach out regarding Mr. Steven Black's refrigerator model # RM2451 w/sn# MB74501204.

Nature of Complaint: Fridge not cooling  
 Part Required for Repair: Replace fridge

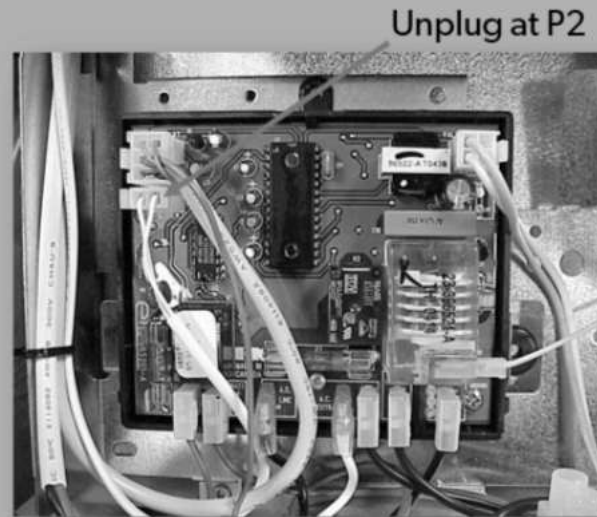
# To Perform a Bypass Test of the Cooling Unit

Disconnect the thermistor from the control board at **P2** (with the thermistor unplugged no temperature is sensed, therefore, it will run continuously). This was designed intentionally so that if the thermistor fails the unit will get as cold as it possibly can since there are no error codes to display and warn the customer that the thermistor has failed.

We are not seeing that the bypass test was done.
