Recall 2022-030

Claim Preparation & Repair Instructions

Recall 2022-030 Repair Instructions

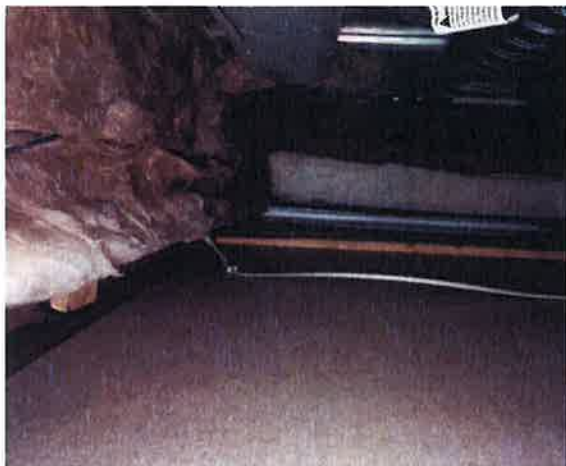
Step 2:

Inspect the 110-Volt wiring behind the refrigerator. It must be secured to the wall, away from the chimney and refrigerator cooling unit. Any signs of discoloration or charring on the insulation of the 110-Volt wiring will require that section of wiring to be replaced using Molex connectors in the refrigerator cavity.

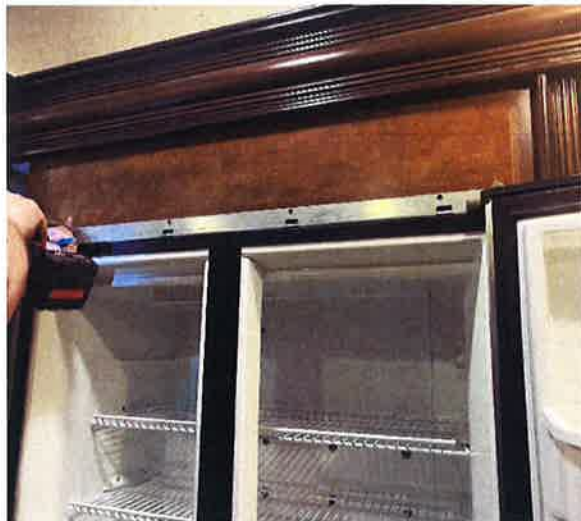
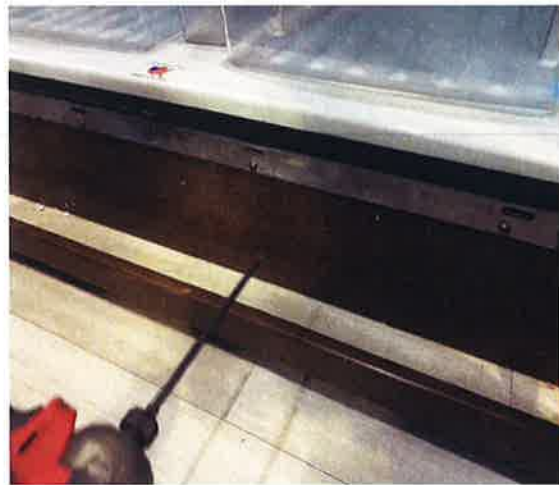
Step 5:

Open the door(s) to the refrigerator, remove the upper and lower covers to access the screws securing the refrigerator in place.

Once all 110-Volt wiring is secured to the wall, reinstall the refrigerator into position and secure with screws as discussed in Step 5.

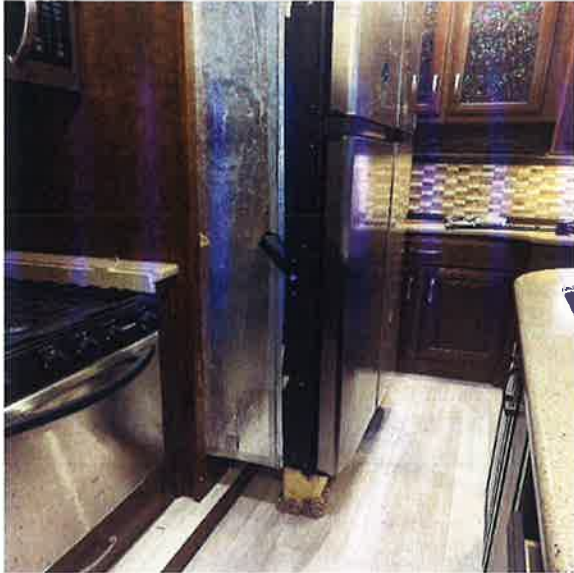
Step 6:

Slide the refrigerator forward approximately 15"-18" out of the cavity. Use wood cribbing cut to height to support the front of the refrigerator. Be careful to use something soft to protect the flooring of the unit.

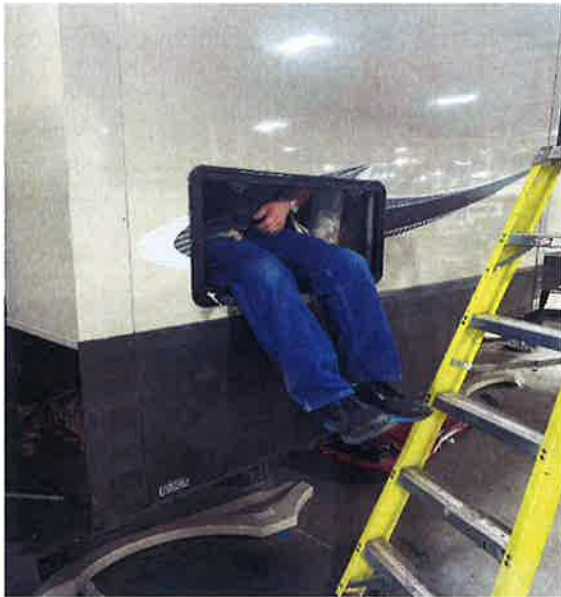
Step 7:

Access the refrigerator wiring through the exterior lower refrigerator vent.

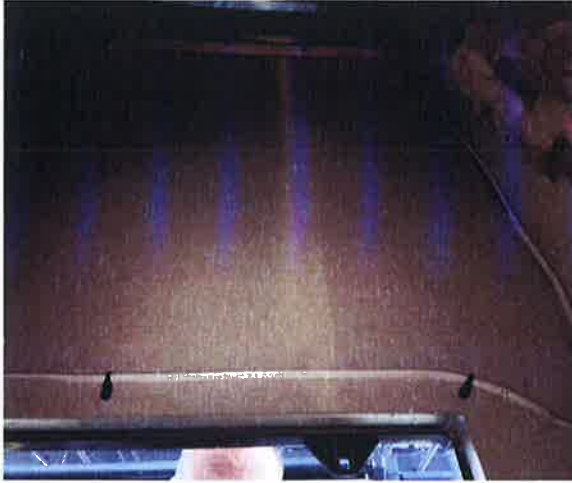
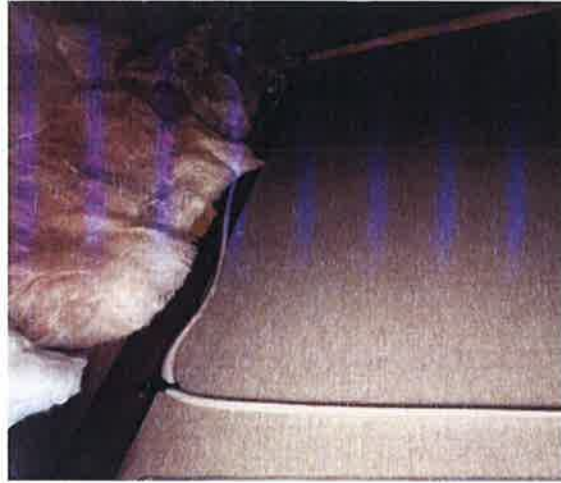
Step 8:

Secure the 110V wires behind refrigerator. This is the time to repair any damaged wiring. Remove all slack from the wire by securing with additional screw mount cable ties and #8 X ¾" screws **every 12 inches**. When securing the wiring, screw into a wall cleat or wall tubing. If you attach to an open wall cavity, use a wall molly to hold the zip tie fast.
