**Claim 2702339 - Labor Line 4**

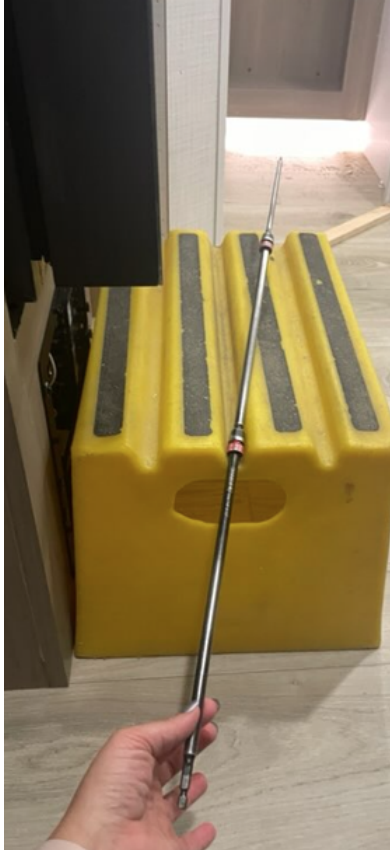
This was where you take the header off the door and use stacked drill bits like this to get the screw replaced.

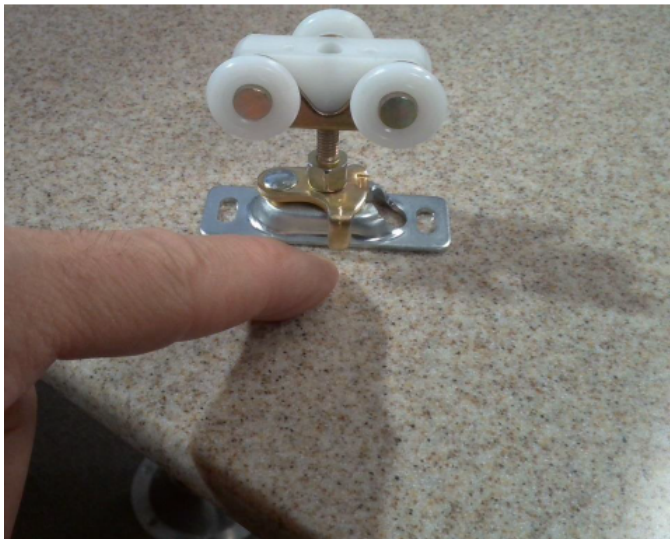
The screws also need to come out of the top of the door that are holding the rollers in.

Remove the one here
